**Subject :** Half yearly EC compliance report of Sindesar Khurd Mine for the period of October to March 2020.

**Name of the Project:** Sindesar Khurd Mine  
(Hindustan Zinc Ltd.)  
Village :Sindesar Khud ,  
PO Dariba ,Tehsil : Railmagra,  
Dist : Rajsamand. Rajasthan.

**4<sup>th</sup> Visit Report –18-20 July, 2019, SK Mines, HZL**

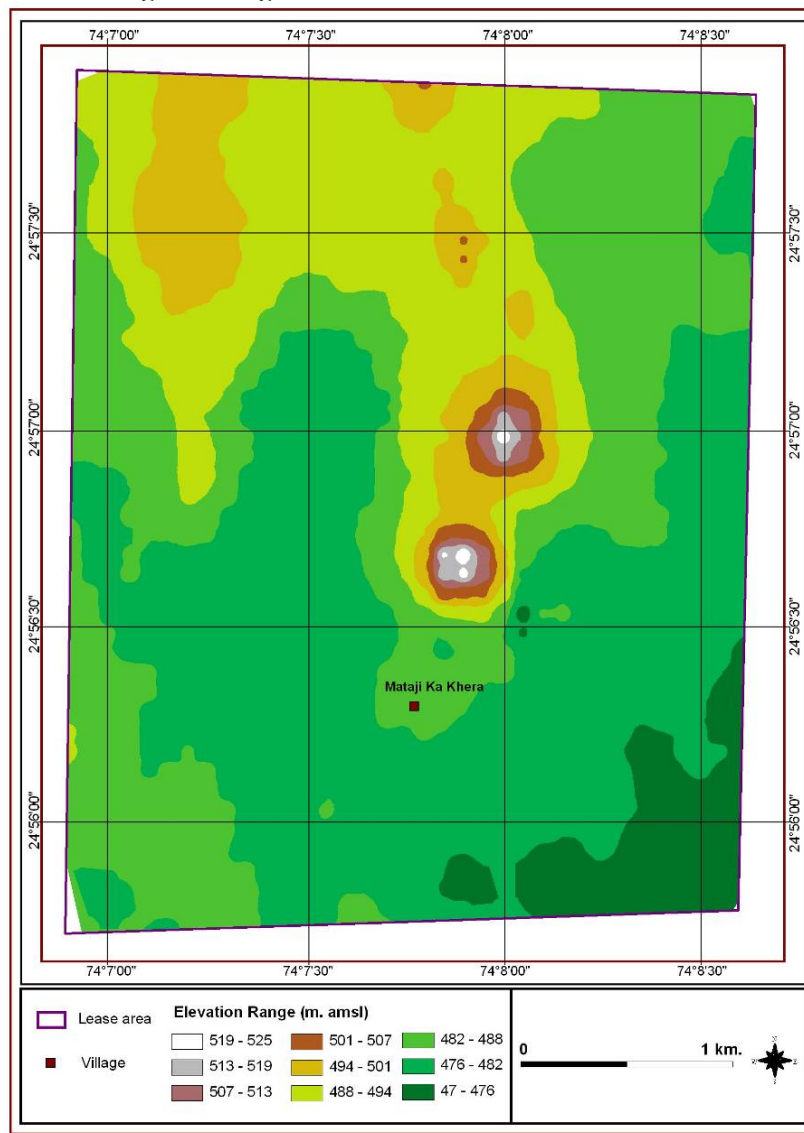
**Figure-8. Digital Elevation Model of the lease area**

The digital elevation model shows **(Figure-8)** three small hillocks with elevation ranging from 559 meters to 470 meters in the central portion of the area. Thus following the topography, drainage is mostly from center towards east and west and drainage density is very poor. There is a canal entering the lease area from west then moving to the central portion and then finally going out from the southern boundary.
